### **Imaging Bond Testing**

**Dr Matt Crompton**

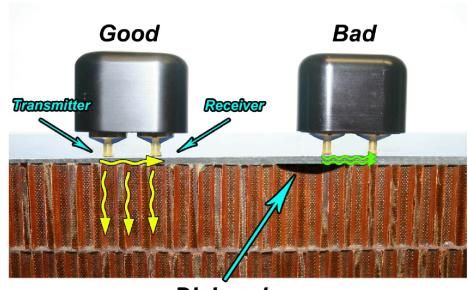
#### **Pitch-Catch Mode**

- Probe consists of a transmitter and receiver element on separate tips
- Transmitter 'pitches' a burst of acoustic energy that propagates into the test part. Receiver 'catches' the sound.

- Bonded condition- Sound waves propagate across the skin, with significant attenuation into the core
- Disbonded condition- Little attenuation into the core giving higher amplitude at receiver
- Easy calibration and no couplant is required, fast, high penetration

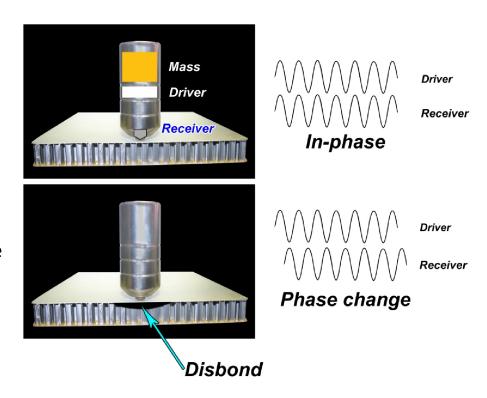
## Mechanical Impedance (MIA) Mode

- Probe consists of driver and receiver elements coupled in series with a single probe tip.
- The loading of receiver element, in the tip, is related to the stiffness of the test part
- When the system is 'nulled', the driver and receiver elements vibrate together with the same phase and amplitude
- As the receiving element moves to a disbonded area, which is weaker, the phase and amplitude of the signals change
- No couplant, accurately locates defects, works on stiff, irregular & curved surfaces

Frequency Range 4kHz-30kHz

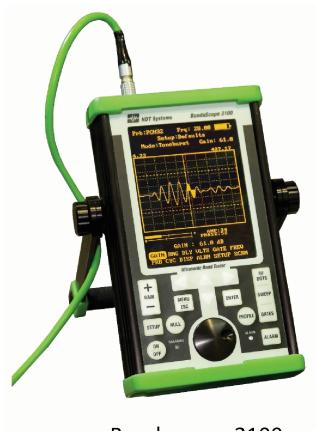
Bondascope 3100

- Single point measurement
- Hard to understand
- Not always possible to distinguish between signal and noise
- Inspector can miss defects easily
- Can be slow
- No digital archive

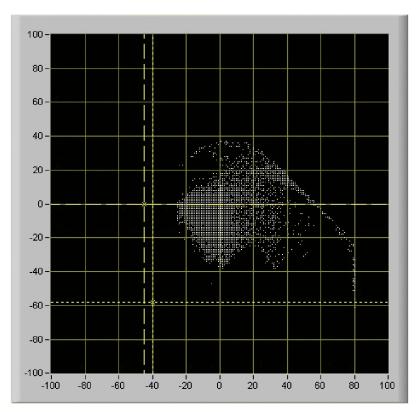
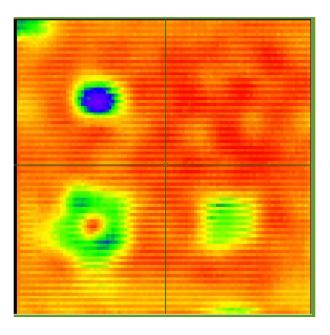
- Marine Glass Fiber/ foam core
- 3/16" skin, chopped mat, 0/90° and 45° lay-up
- UT cannot penetrate, Resonance and P/C failed
- MIA measures an out-of-plane stiffness

Amplitude showing skin-core disbonds

Impedance plane scatter plot

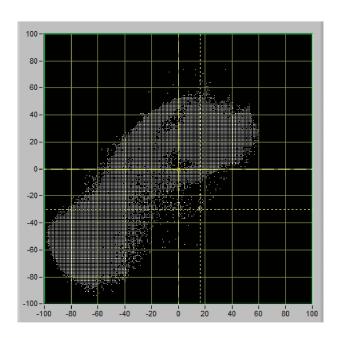
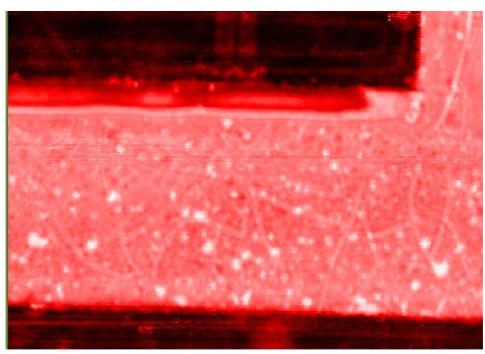
Bonded carbon laminates

Resonance inspection of adhesive glue line- showing cracks and voids in the adhesive through the carbon

skin.

Vertical cracks represent a few pixel shift, not possible to detect manually

X-component- impedance plane

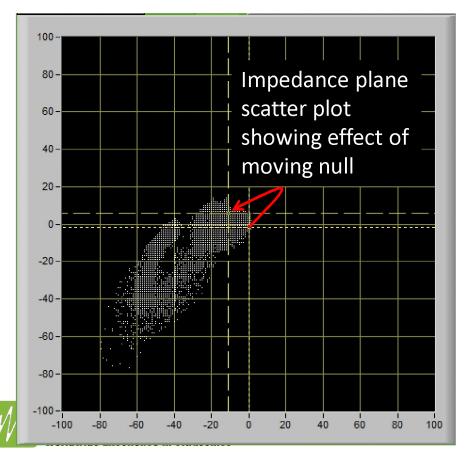
- Carbon skin/ honeycomb sandwich panel
- Near and far-side defects skin-core disbonds
- Cannot see all defects in x,y or amplitude
- 110kHz resonance mode, phase display

Phase, with instrument null point

Phase, with adjusted null point

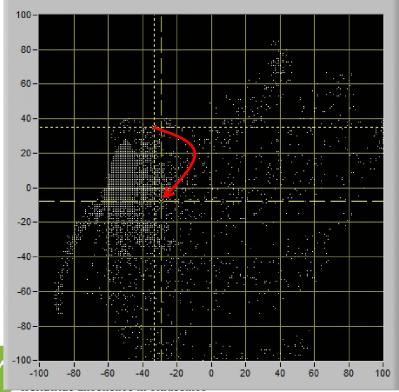
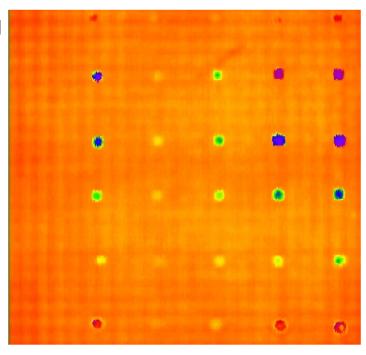
- Aerospace Composite laminate Reference Standard
- 30 ply with brass foil, Armalon, release ply F, poly backing material, pressure sensitive tape inserts at different depths. (BAC5578 Inserts)
- 2 plies from near surface to 2 plies from far surface
- 110kHz resonance mode (compromise)

Phase display

Impedance plane scatter plot with adjusted null

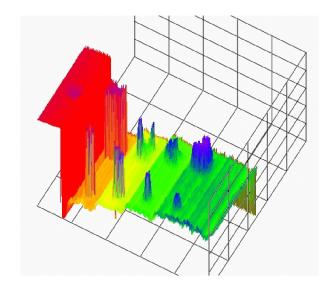
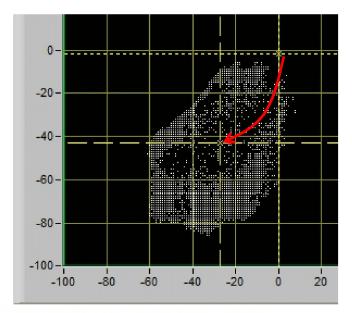
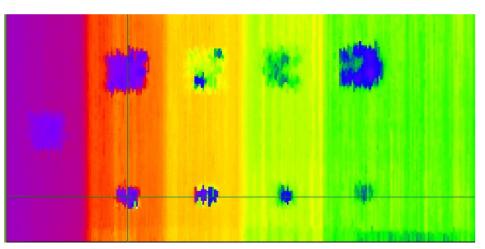
- Resonance inspection of carbon laminate step block with inserts.
- Thickness range- 0.014" 0.070"
- Both the change of thickness and defects affect phase and amplitude

Phase display

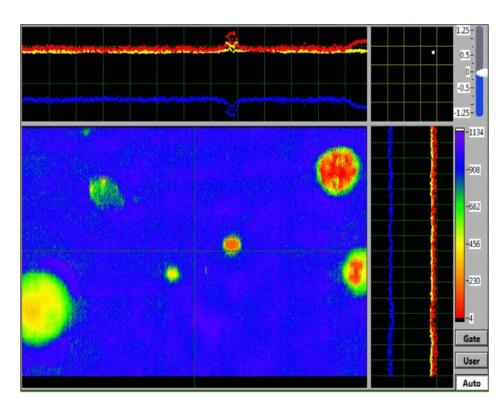
- Satellite panel- a carbon skin, aluminum honeycomb
- Dry coupled MIA mode
- Crushed core, disbonds, far-side defects and more
